**Geotextile tube oil-pipe
foundations in Tabasco**

PEMEX marine facilities in Tabasco, Mexico

Geotextile tubes are integral components for oil-pipe foundations, erosion control

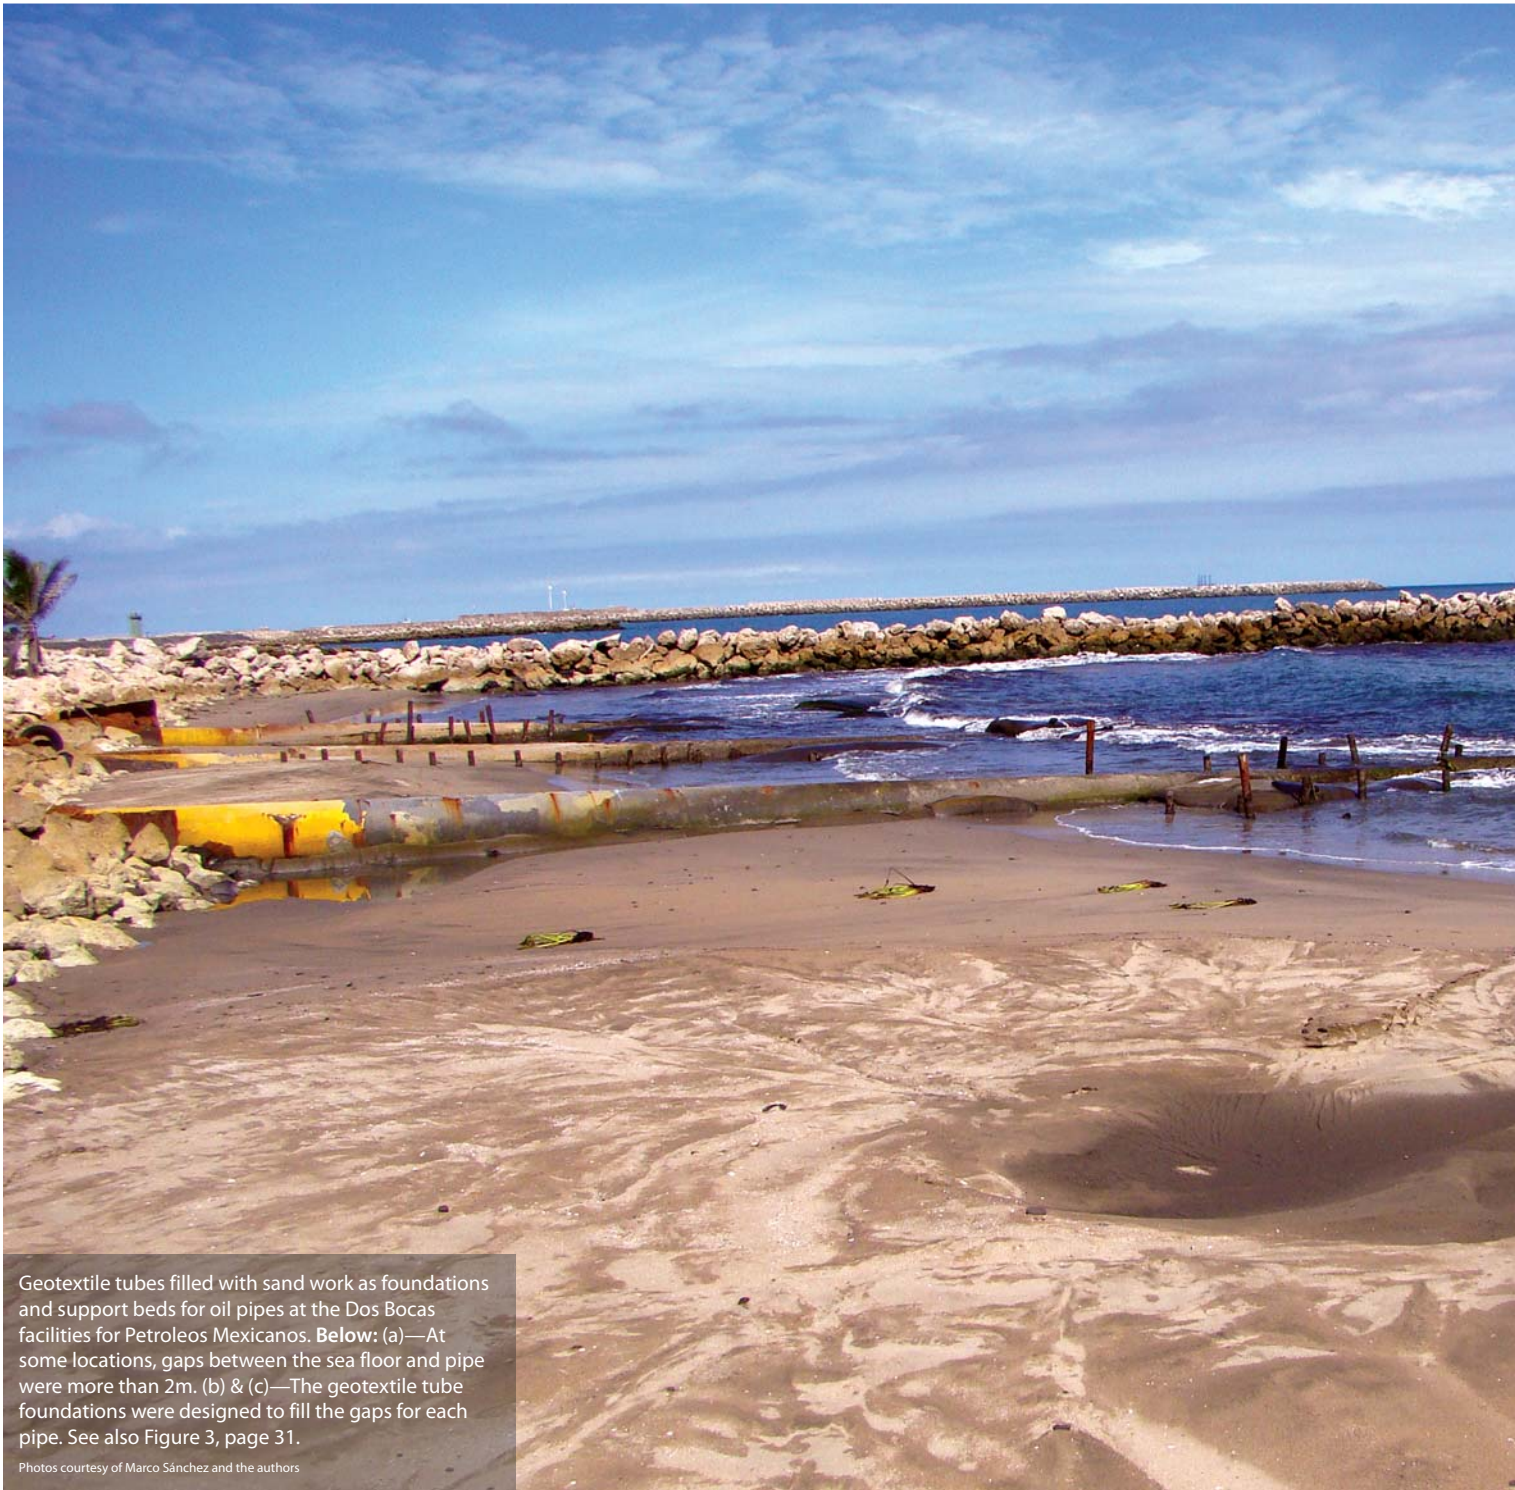
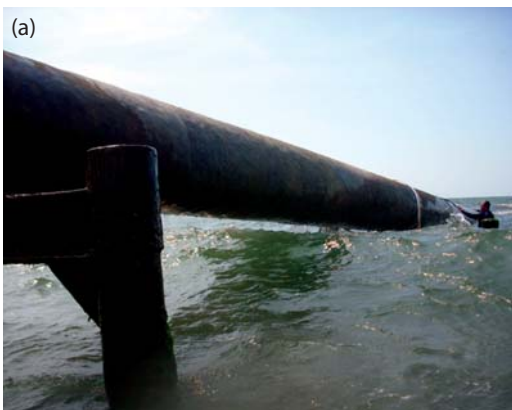
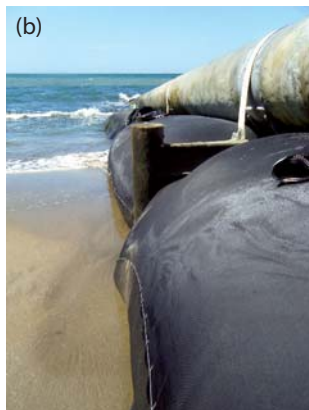
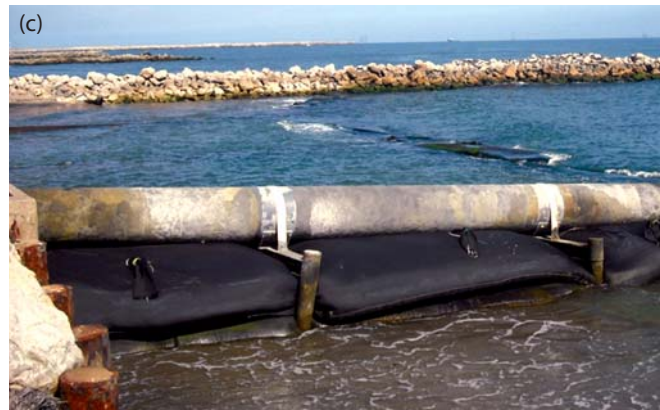
Geotextile tubes filled with sand work as foundations and support beds for oil pipes at the Dos Bocas facilities for Petroleos Mexicanos. Below: (a)—At some locations, gaps between the sea floor and pipe were more than 2m. (b) & (c)—The geotextile tube foundations were designed to fill the gaps for each pipe. See also Figure 3, page 31.

Preliminary study results showed that 5 of the 7 oil conduction pipes had lost their foundations due to beach erosion. The most critical cases were detected along pipes 6 and 7 where, at some points, gaps between the sea bottom and pipe were at 2.5m—see **Photo (a)**, page 28.

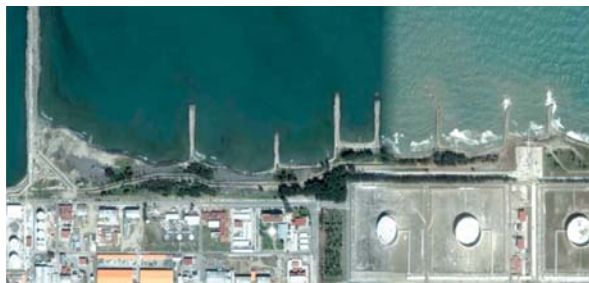
FIGURE 2 Aerial view: Project coastal area

Figure 2 depicts the coastal area where this project was developed. The area is divided into seven sections, each one delimited by the existing groins.

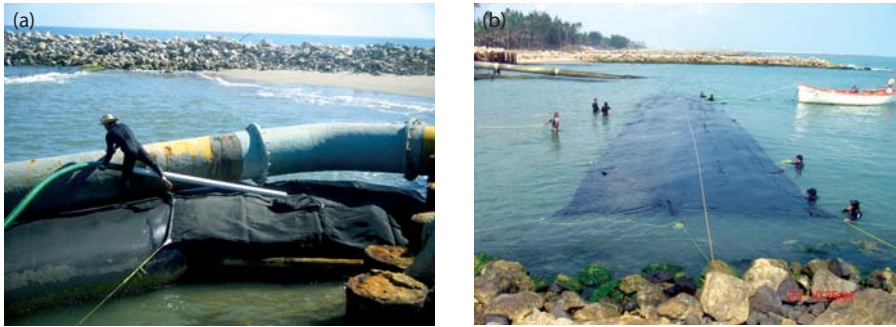
FIGURE 6 Filling GT tasks: (a) pipe support elements and (b) breakwater

Figure 6 shows slurry-pumping operations for both the GT support elements and breakwaters. Pumped material was obtained from submarine banks 50-70m offshore.

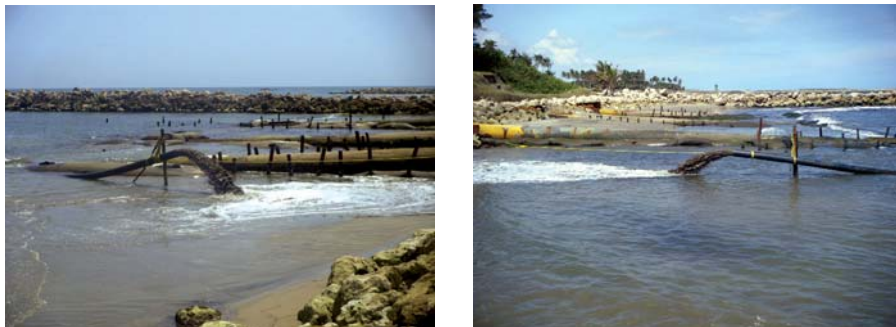
FIGURE 7 Beach nourishment activities

Once GT installation was finished, beach nourishment continued using a 12-in.-diameter suction dredge, with volume discharge rates up to 250m³/hr. Material was conducted to shore by a 10-in. flexible hose (Figure 7).

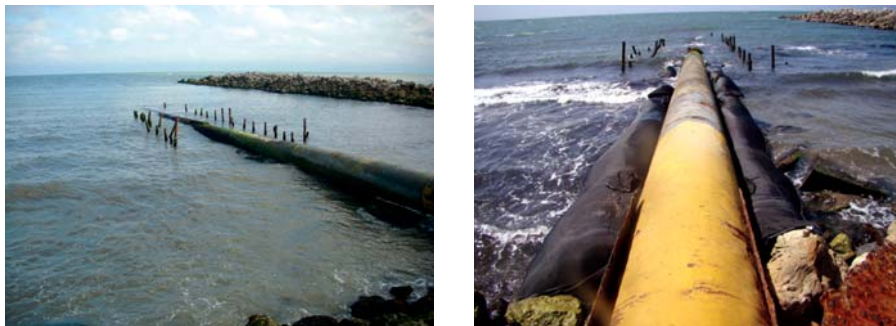
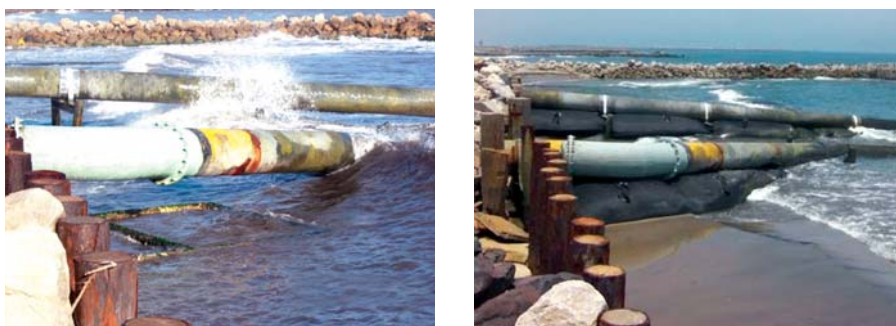
FIGURE 8 Before-and-after comparison for pipe 3

FIGURE 9 Before-and-after comparison for pipes 6 and 7

Figures 8 and 9 show before-and-after comparisons. In some cases, gaps had reached 2.5m. The photos also show the GT's flexibility and adaptation to marine media—key points for this project's success, giving complete support where required.

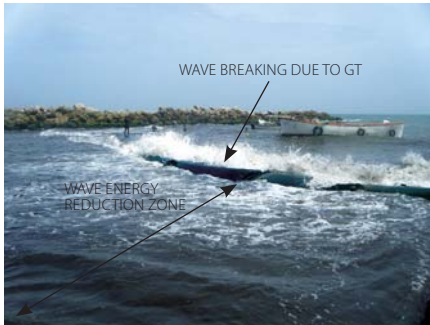
FIGURE 10 Breakwater performance

As for breakwater performance, Figure 10 shows the wave-breaking concept due to GT presence, creating a wave energy reduction zone, with turbulence generated shoreward inducing sand accumulation.

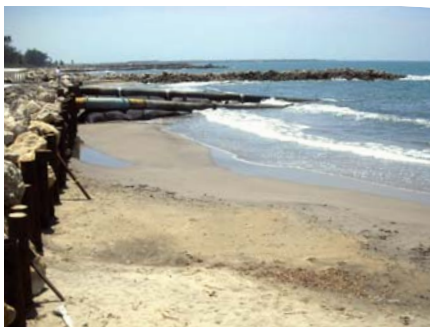
FIGURE 12 Final situation for section 7

Beach fill construction clearly enhanced project performance, providing additional stability to the shoreline and the support elements for the oil-conduction pipes. And as the breakwater continues to reduce longshore transport rates and minimizes end losses, it will ensure the lifespan of service for this facility (Figure 12).

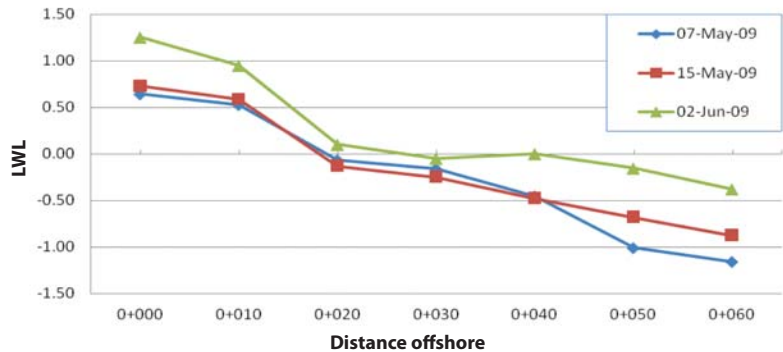
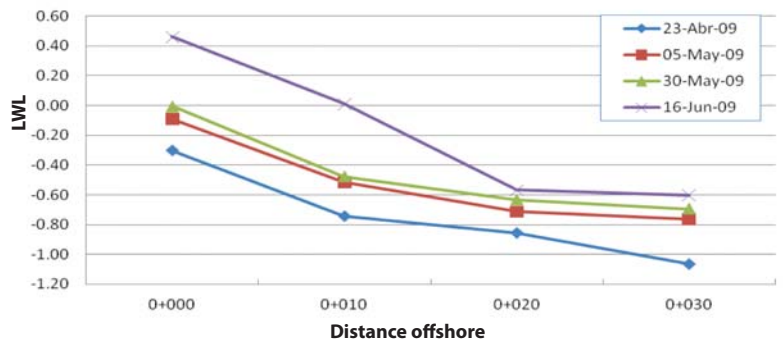
During the breakwater installation process, beach evolution profile surveys were done for all sections, corroborating that the structure was performing as expected, promoting natural sand accumulation shoreward of the structure (Figure 11).

FIGURE 11 Beach profile evolution after breakwater installation: (a) Section 1, (b) Section 7
